## Scaffolding Enclosure for Roof Repairs **NATURAL HISTORY**

## **MUSEUM** Overcoming Limitations of the Project

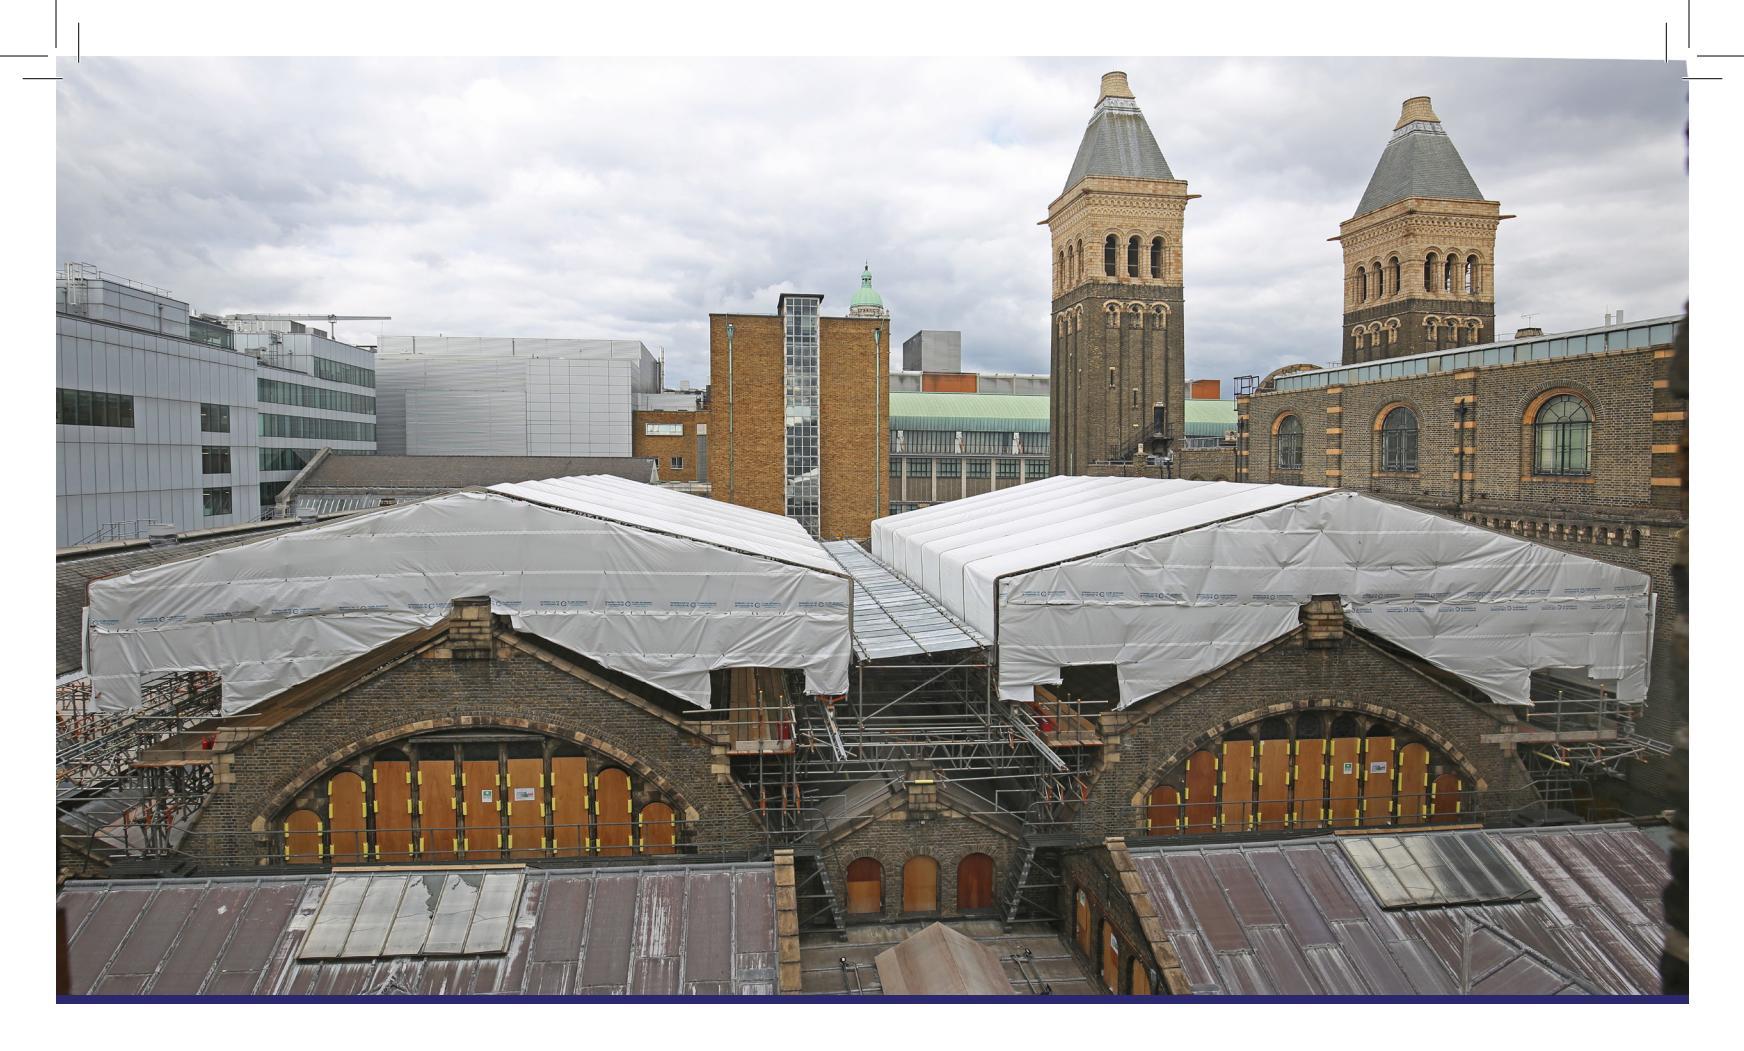
brackets to take bearing from the existing masonry wall and transfer the load to the ground. This was necessary because the scaffold was "landlocked" on one elevation.

The bearing of the historical masonry lime mortar walls was limited to 0.8N/mm2, therefore scaffold beam spacings and the number of ScaffPutLoad brackets were increased to stay within permissible limits.

Internal support towers were also founded on steel UB spreaders to ensure the existing gallery floor was not overloaded and the use of the gallery could be maintained.
